**FACILITY STATUS CHANGE FORM**

<b>Date Submitted:</b> 9/01/2016	<b>Area:</b> 200W	<b>Control Number:</b> D4-REDOX-031
<b>Originator:</b> D. Turlington/S. McMahan	<b>Facility ID:</b> 2711S	<b>Phone:</b> 509-376-0176

The required facility removal actions were performed in accordance with the DOE/RL-2010-33, Rev. 0; *Removal Action Work Plan for Central Plateau General Decommissioning Activities*.

Building 2711S was constructed in 1952 in the 200W area east of REDOX. The building was used for gas monitoring and storage of samples from 291-S-1 stack (Attachment 1). Demolition of building 2711S was performed during August of 2016, the facility was removed, leaving slab on grade. Waste associated with this demolition was characterized under Waste Profiles WC-PRCIF002 Rev 4 and WPPRCIF001 Rev 9, and disposed of at the Environmental Restoration Disposal Facility (ERDF).

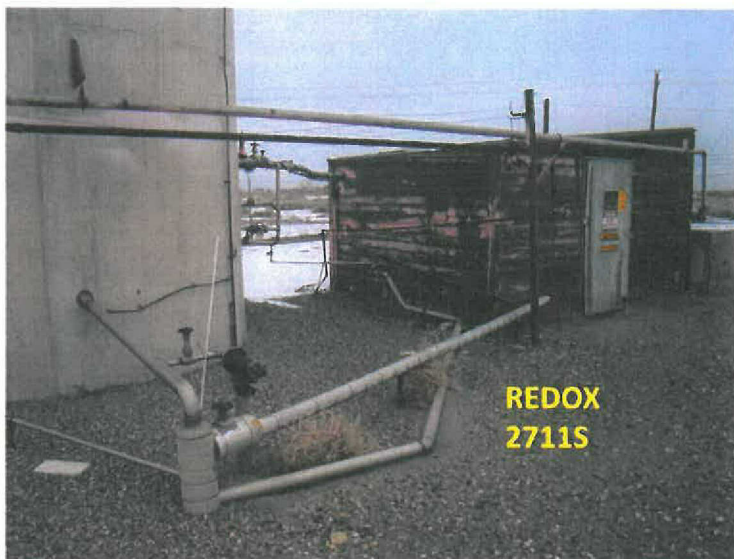
2711S Pre Demolition

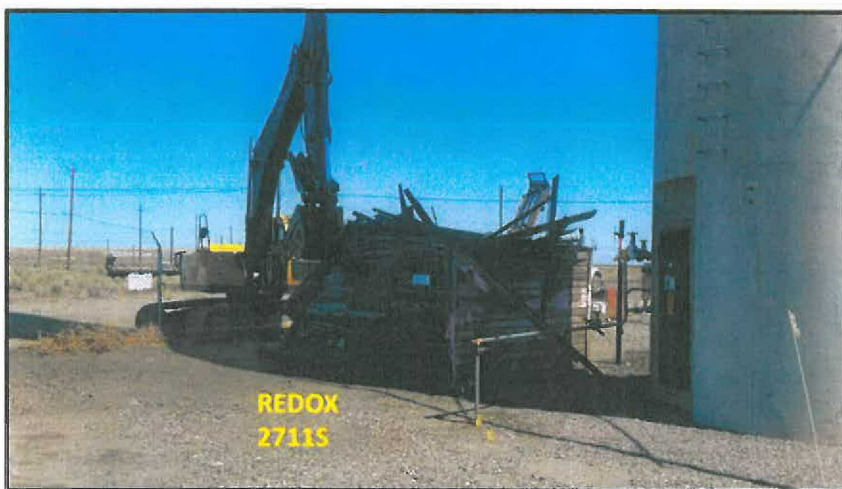
2711S During Demolition

- The structure 2711S was demolished to slab on grade using heavy equipment (e.g. excavators and track hoes).
- All waste generated during demolition was characterized, shipped, and disposed of in accordance with waste management ARARS and WCH-191, *Environmental Restoration Disposal Facility Waste Acceptance Criteria*, as amended.

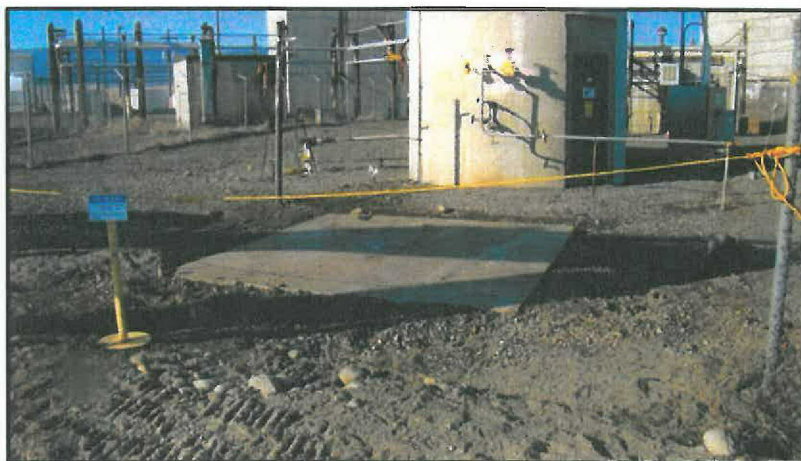
2711S Post Demolition

Building 2711S was removed to slab on grade and no safety hazards remain.

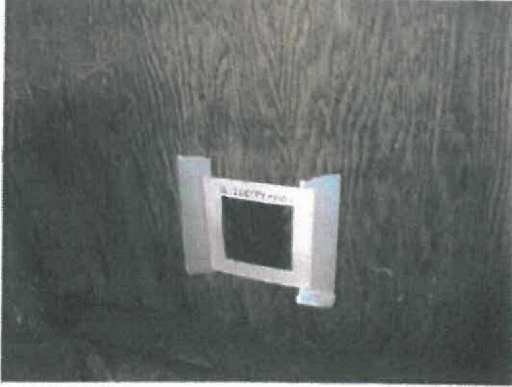
**16-20094-001**

Sample Number	Sample Date	Sample Result ( $\mu\text{g}/100\text{ cm}^2$ )	Control Level ( $\mu\text{g}/100\text{ cm}^2$ )	Sample Location
16-20094-001	01/20/2016	0.025	0.2	Inside of opened south door.
16-20094-002	01/20/2016	<0.025	0.2	Inside wall, left of south door.
